# Manhole Inspection Summary

Manhole # S170\_\_022MH

**Inspection** ☐ Is Incomplete Rating: **4) Poor**

**Location** Address: **2533 millington-helen alley**

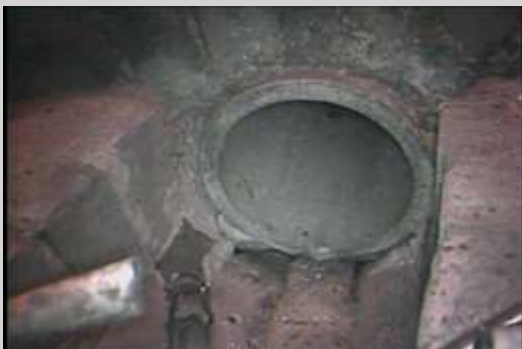
7 O'Clock Inflow

8 in. Circular Gravity Sewer  
Pipe In @ 7 O'Clock

Pipe Height: **8.4** (in.) Rod and Bar (Angled)  
Pipe Material: **Clay** ☐ Pipe Lined  
Invert Depth: **10.08** (ft.) Flow Characteristics: **None**  
Deposits: ☒ **None** ☐ Mud ☐ Sludge ☐ Debris ☐ Grease  
Silt Depth: **0** (in.) Deposits Extent:  
Infiltration: **None** Pipe Seal Cond: **Sound**
